Australian Compliance Laboratory

Test Report

Report ID ACL1357 issued 25 March 2022

Testing a weldless steel guardrail assembly to the requirements of AS 1657 (2018),
Appendix B.

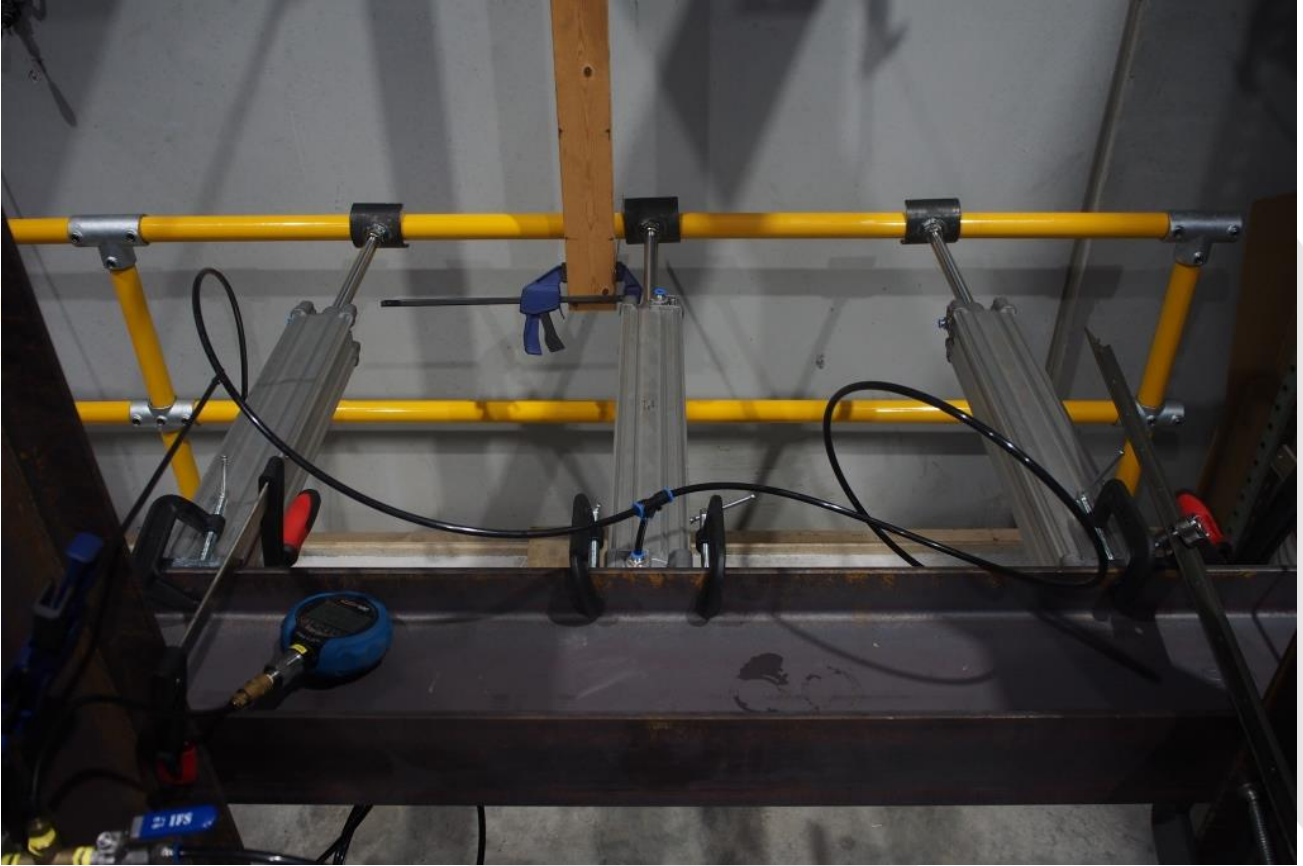
Appendix D – Uniform distributed load picture

- No permanent deflection was observed.
- The test load was applied using pneumatic rams and the force was measured using a pressure transducer.
- The uniform distributed load (UDL) tests were conducted using three pneumatic rams with a spacing of 515mm.
